Rowlesburg Ontrac Design Site Visit Report

Walking workshop segment of site visit

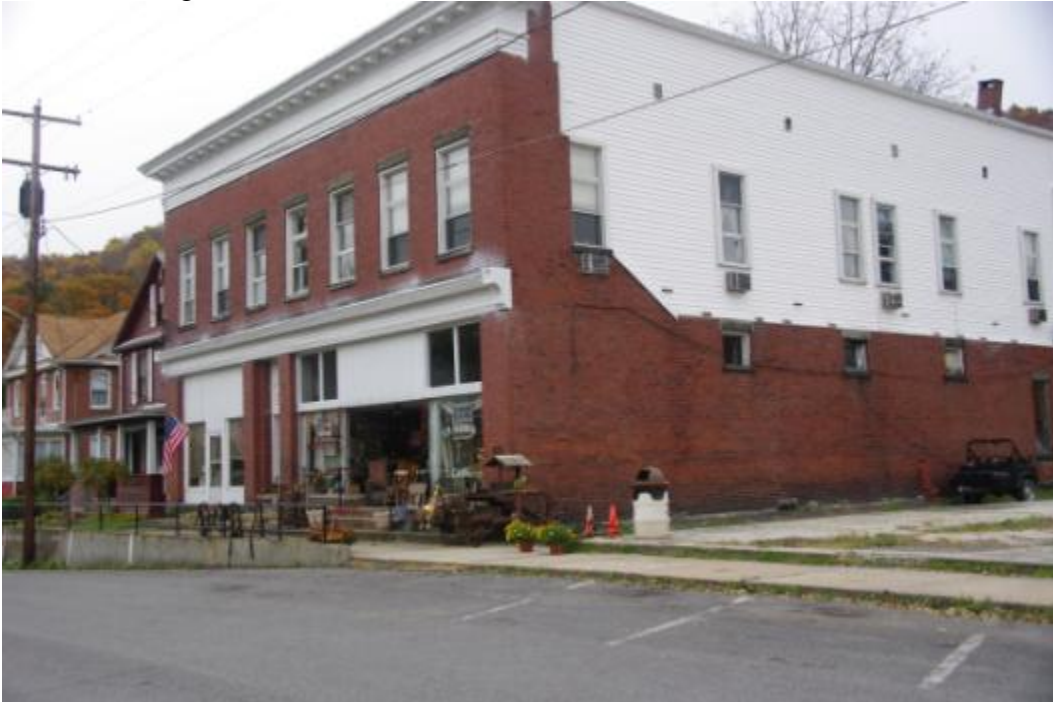
- Hollis Building

- We reviewed with the owner rehabilitation techniques. They appear to be doing a admirable job of maintaining and repairing the building. The major issues include:

- Rising damp on the side. Insure the grade is sloped away from the building and drains.
 - Point the damaged portions of the masonry. Follow Preservation Brief No. 2 for guidance on these.

- If the rising damp becomes more of an issue, consider excavation and installation of French drain at the base of the side walls.
 - Future work: Replace inappropriate siding in transom area in center of storefront with transom or other appropriate element.

- Return left side storefront to original appearance with display windows, recessed entrance and transoms.
 - General repair and maintenance of building.

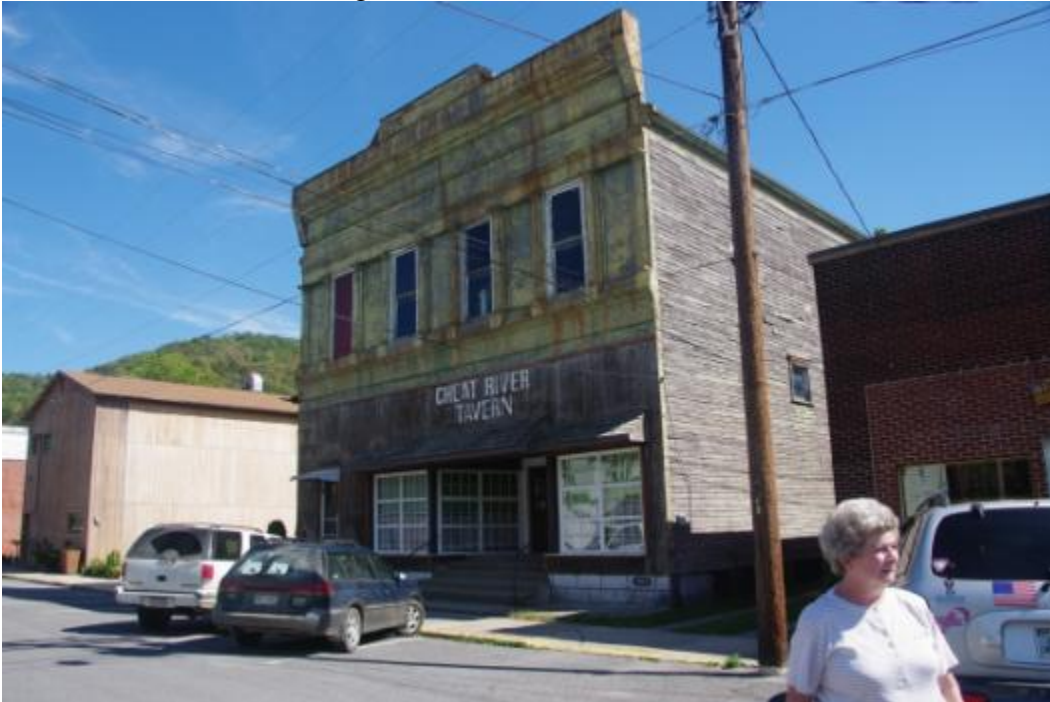
- Cheat River Tavern Building

- This is a very significant historic resource and should be rehabilitated. It is currently vacant and is in poor condition. There are major areas of deterioration. It is still possible and desirable to rehabilitate the building.
- It will be necessary to mothball the building properly for the current time period, until a subsequent owner can rehabilitate it. Mothballing should be done carefully, to protect the building from further deterioration, water and moisture damage, and vandalism etc. See Preservation Brief no. 31.
- The left side wall is the most deteriorated, with much of the siding either missing or damaged. The sill on the side is also damaged in a few locations, leading to structural concerns. Treatments to mothball the building include:

- Install sheathing or siding where it is missing or there are major holes or gaps in the siding that allow water, the elements, insects and animals in. As a temporary measure it is acceptable to use plywood or other material. The long term solution is to install new siding on the entire wall to match the original. Insure that flashing and a sheathing and underlayment are installed at that time.

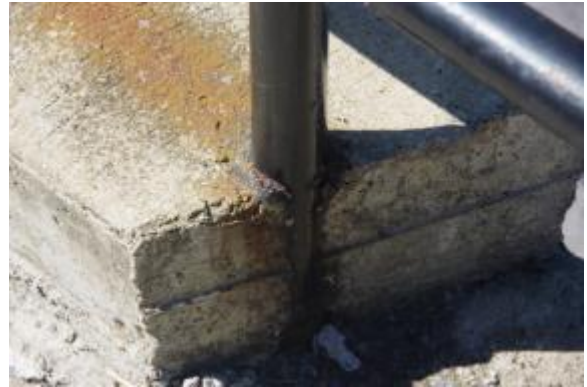
- Another issue is the handrails are set in the concrete and they are causing rust expansion and deterioration.
 - Repair and reinstall the rails in inert non-ferrous methods to remove rust damage.
- A third issue is cracking and age deterioration of the sidewalk.
 - Replace or repair the sidewalks as necessary. Consider using an aggregate finish in lieu of modern broom swept finishes and colored concrete or aggregate to match the appearance of the original.
- The stairs at the end of the wall are also deteriorated and erosion has damaged their supports.
 - Repair the stairs as above. Repair the rails on the stairs and meet current accessibility standards with the rails, such as to have them extend beyond the end of the stairs, size of railing etc.

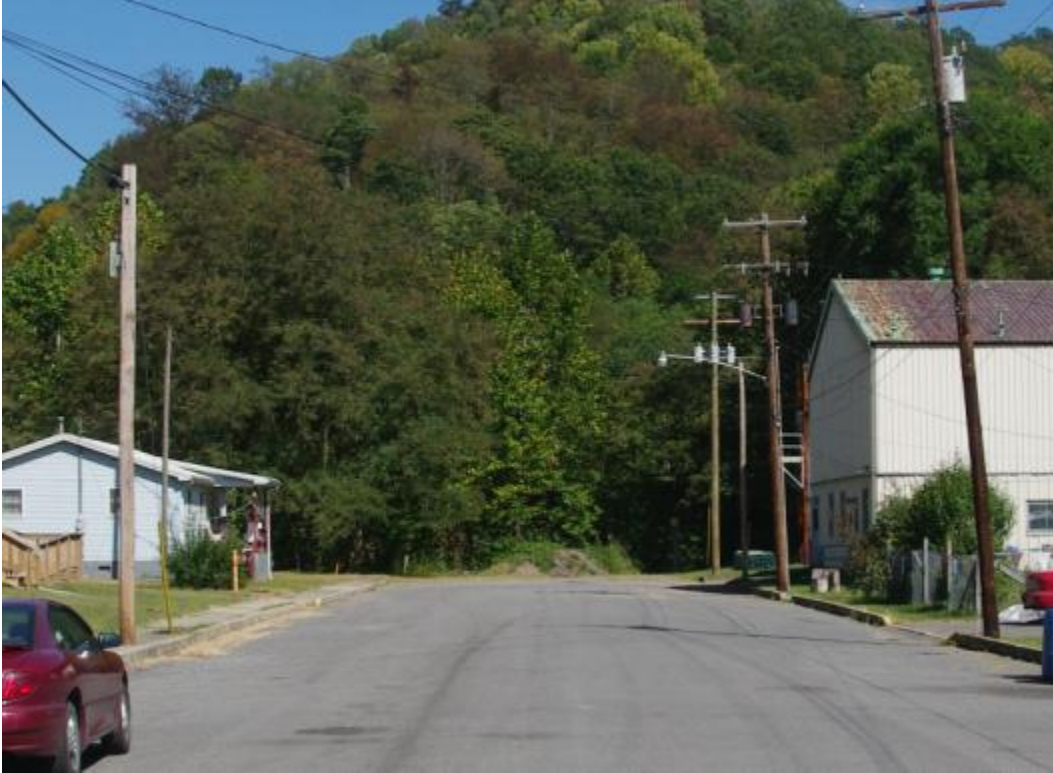
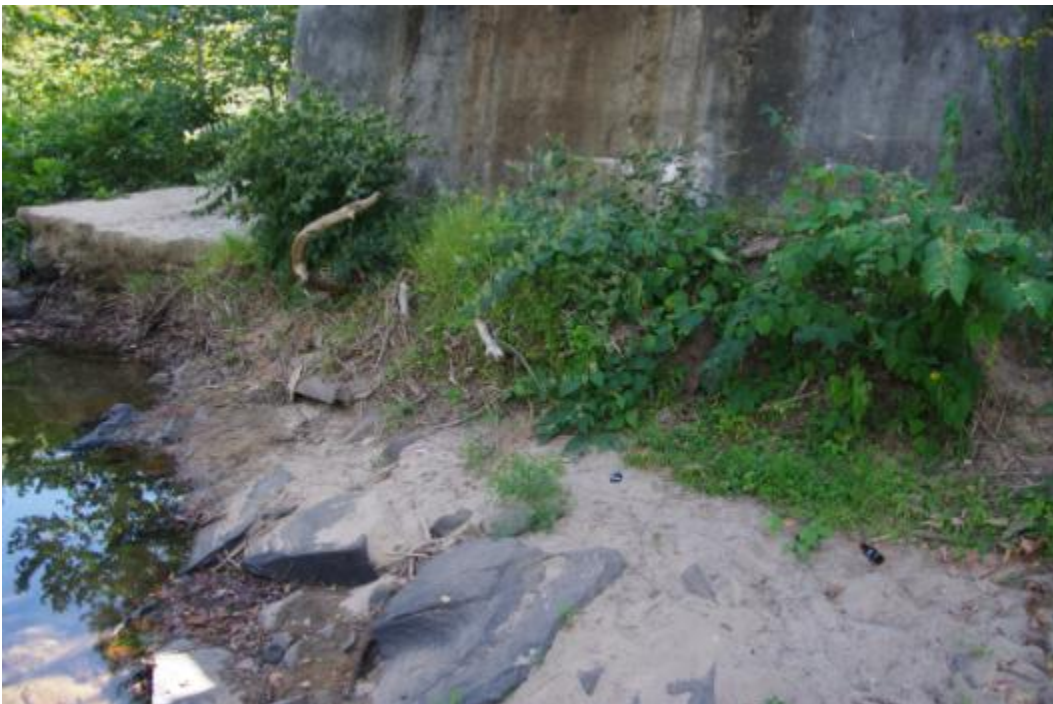
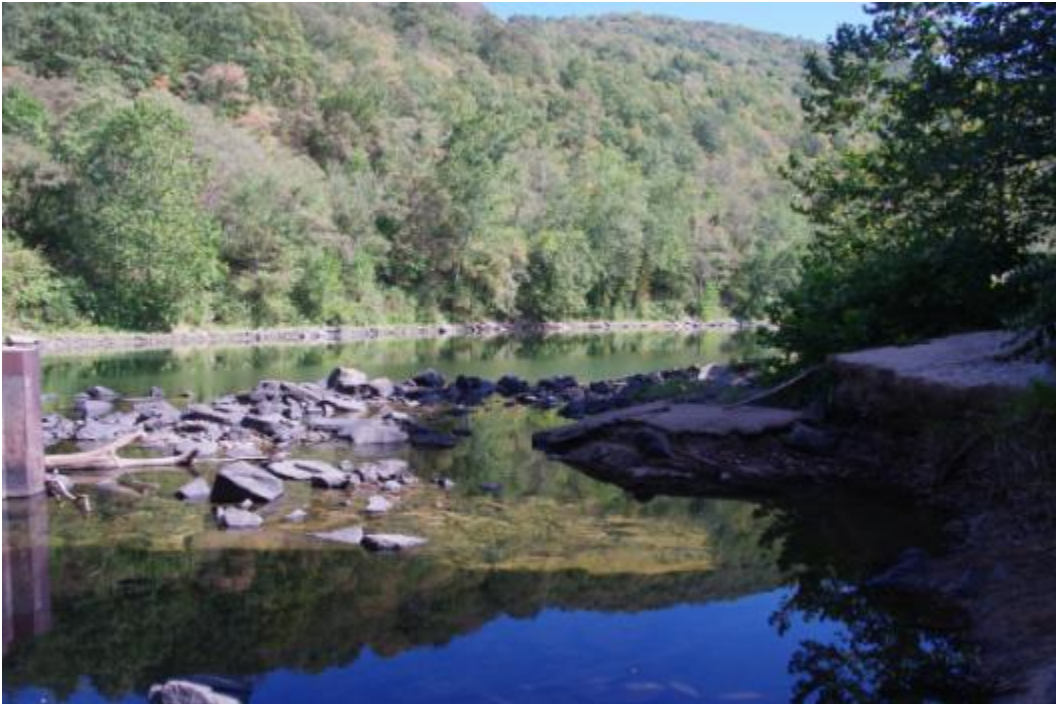
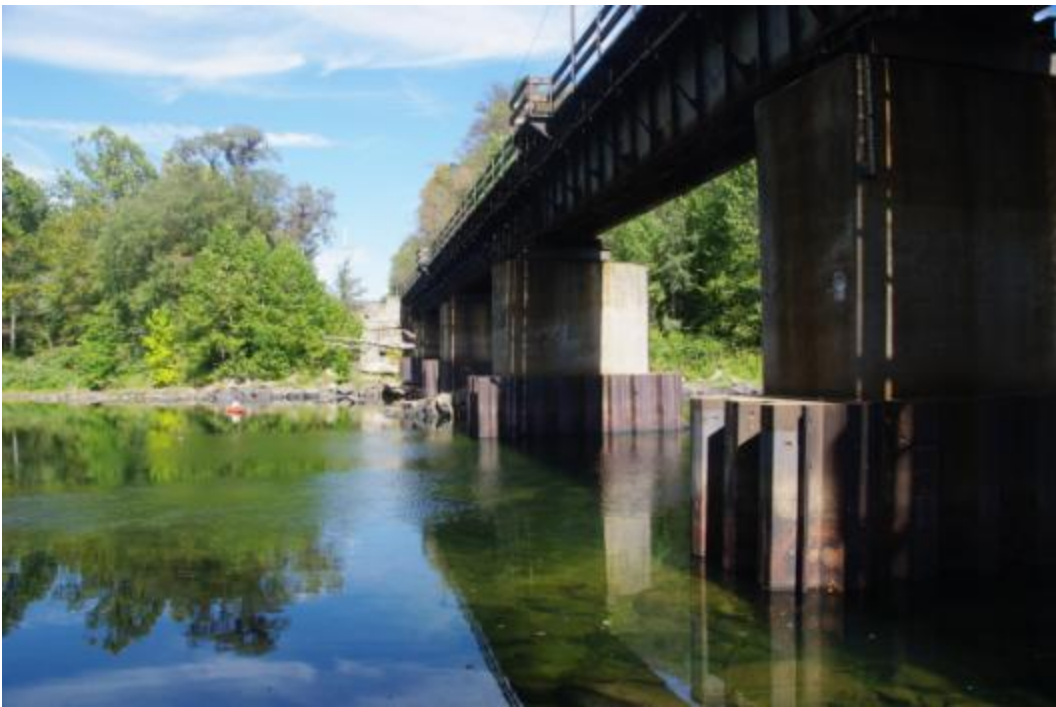
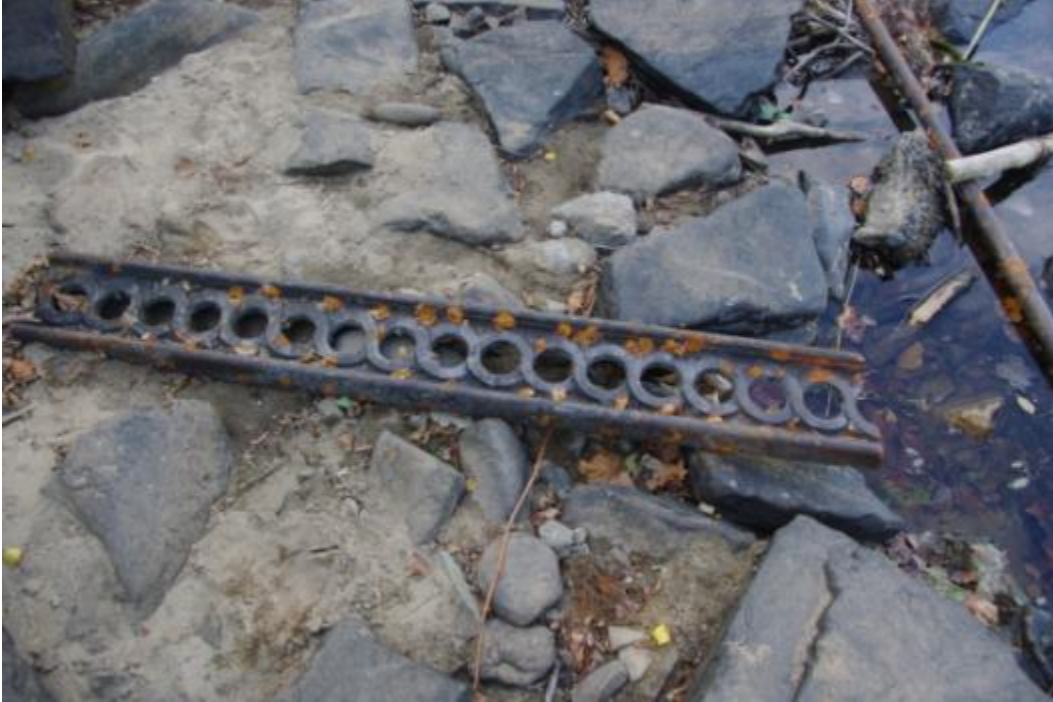
- At the end of Main Street there used to be a concrete platform/deck that served as a river access platform. This is beneath the railroad bridge, and was destroyed in the 1985 flood when the bridge was destroyed. There are remnants left of the concrete pad, at the base of the bridge abutments. the river at this point is a gently flowing wide shallow spot that allows for swimming, boating fishing and other river activities. Just upstream from this area is a wide deep spot in the river that has been the town swimming hole forever. The town has grant to create and improve a fishing access trail at this location and is developing additional recreational activity sites adjacent to the river and the fire station.

- Easy access should be developed from Main Street to the river at this location. it can include stairs and a platform at the top with an informational kiosk, such as at a trail head.

- The concrete deck should be reconstructed to provide river use and recreation.
- The deck, and the Main Street access should be connected to the river trail system on the upstream side of the RR bridge.
